PB92-916501
NTSB/PAR-92/01

PIPELINE ACCIDENT REPORT

NATURAL GAS EXPLOSION AND FIRE
DEPARTMENT OF DEFENSE/ARMY
FORT BENJAMIN HARRISON
INDIANAPOLIS, INDIANA
DECEMBER 9, 1990

ADOPTED: APRIL 8, 1992

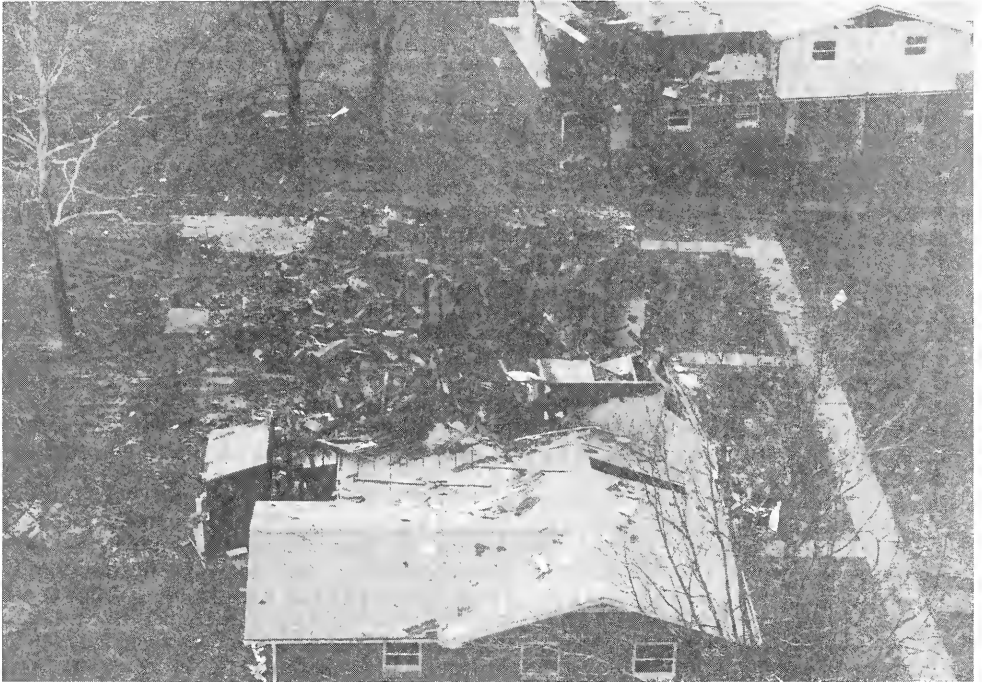
Figure 2.--View of the destroyed and damaged buildings.

The Army Corps of Engineers (Corps) estimated the explosion and fire damages to buildings 1023 and 1024 at \$3,800 and \$48,500, respectively. Building 1025 was destroyed, and the estimated loss was \$300,000. Total building damage was approximately \$352,000. After the accident, the gas company replaced the entire village gas distribution system at a cost of \$147,000 to the Army. Also, flexible gas fuel piping and vent pipes within the village were replaced at a cost of \$73,000.

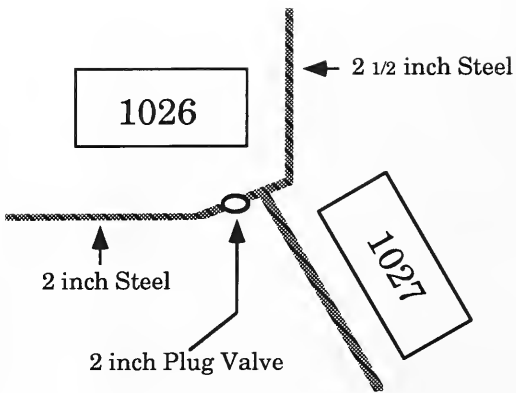
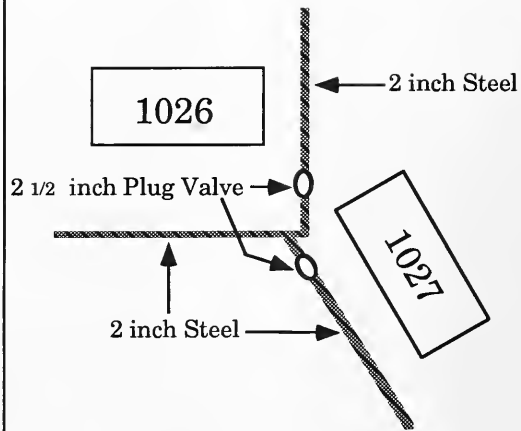
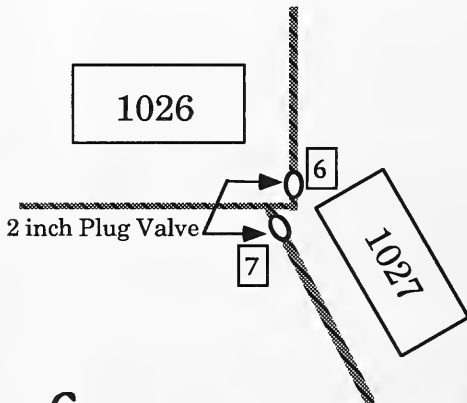
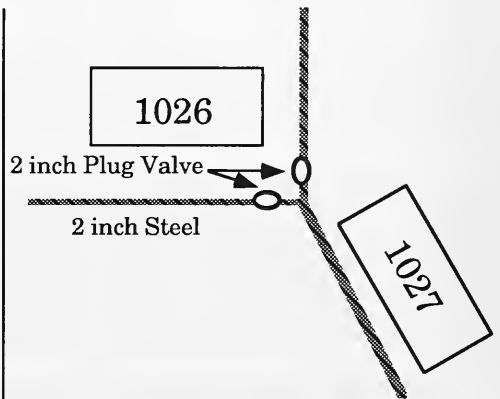
An approved-for-construction drawing dated 1971 did not show the valve behind building 1027 but did show the valves beside and behind building 1026. (See figure 4D.) This drawing also did not show the distance between the buildings and the gas mains.

D. 1971 Approved for
Construction DrawingFigure 4.--Valve arrangement between buildings 1026 and 1027
as shown on various Fort documents.

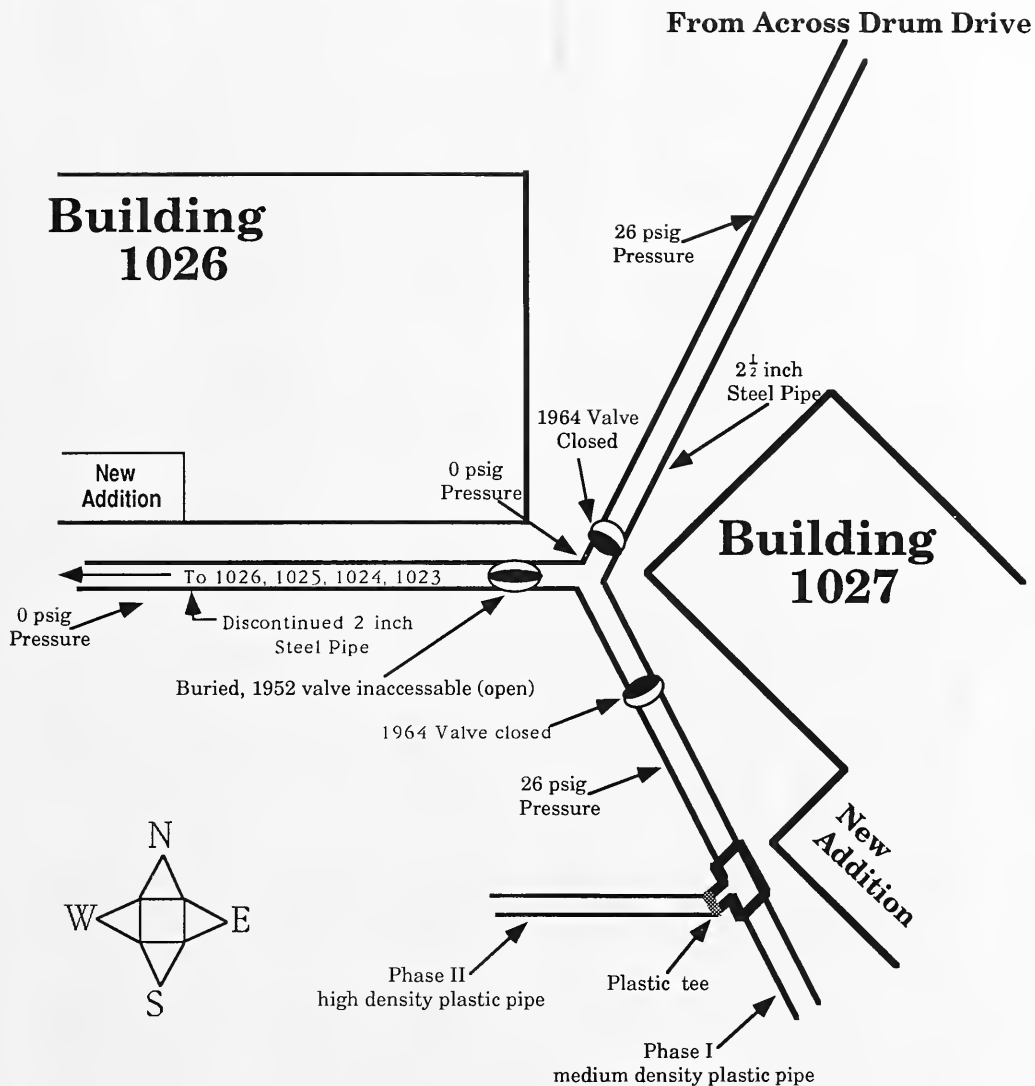
The contractor's as-built drawing showed that some of the old steel piping loop between buildings 1027 and 1035 remained. The drawing also indicated that two new valves had been installed during Phase II to replace valves abandoned between buildings 1027 and 1028 and between buildings 1033 and 1034 in that nine-building loop. The steel piping not replaced in the loop was not pressure tested or otherwise checked for leaks, and its corrosion protection system was not tested to determine whether the anodes had remained in electrical contact during the construction and whether the electrical protection was adequate to prevent corrosion.

Figure 5.--Schematic showing the gas pipes and valves near buildings 1026 and 1027 as found after the accident.
